## **Case Study #1**

### **Nelgar's 'Wireless'**

**Foreman's Report/Work Order**

**Dynamometer Analysis**

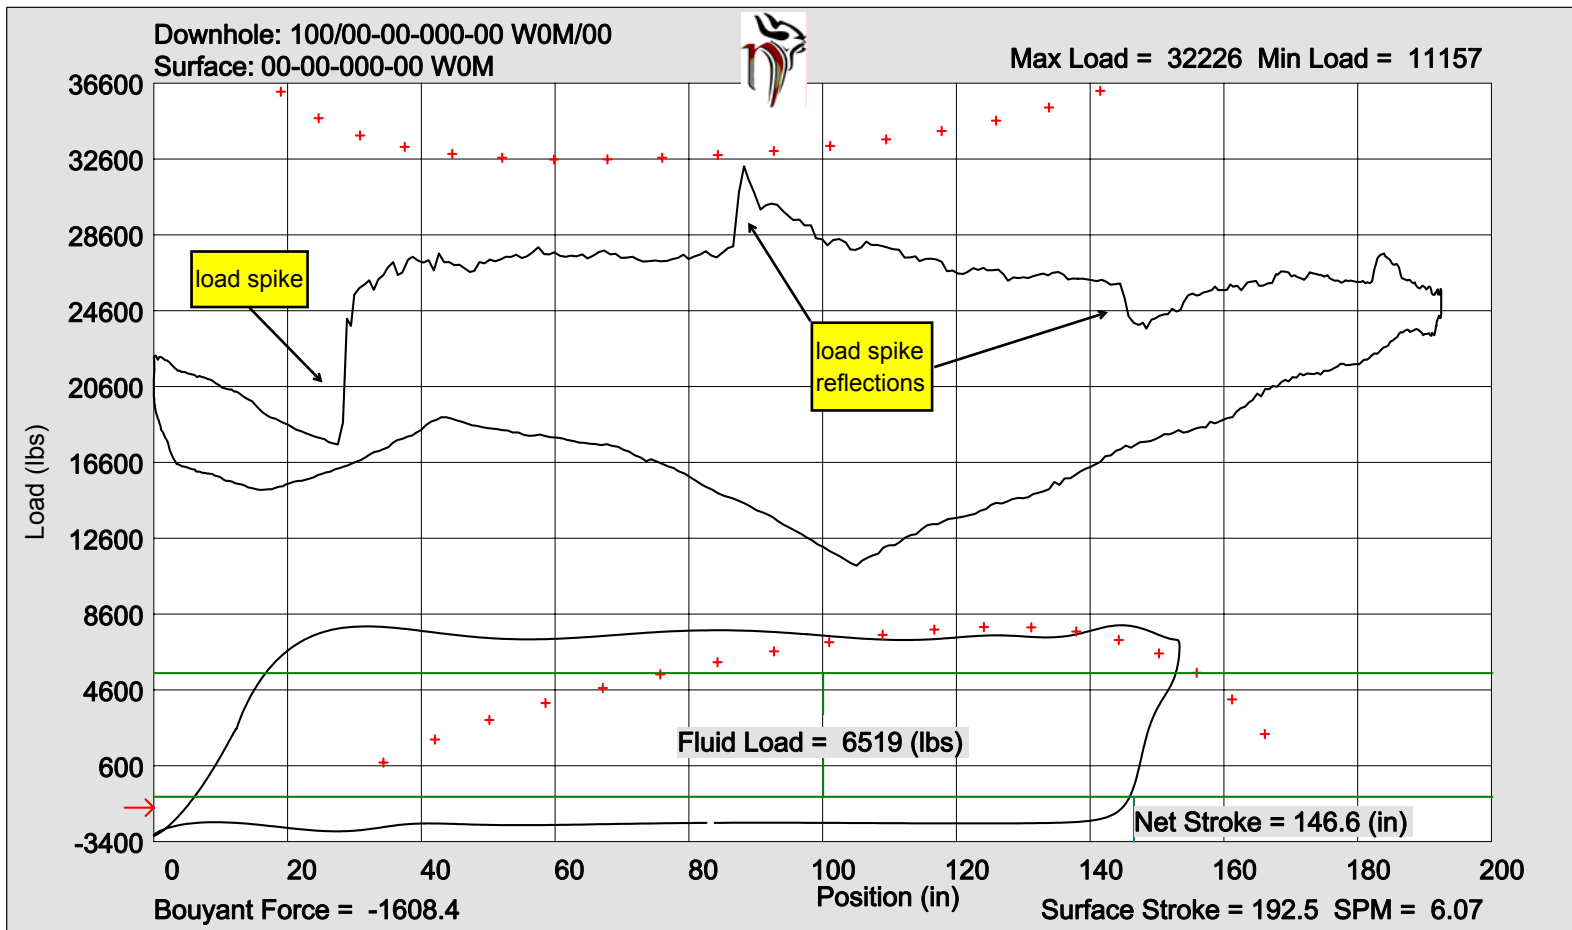
1. The well was observed and tested for possible causes of knocking at the beginning of the upstroke. The dynamometer test results indicate a sharp load spike approximately 10 to 30 inches into the upstroke. Its reflections are evident throughout the stroke (see page 3). Consider reversing the unit rotation and inspecting the gearbox for possible chipped tooth. Monitor production, allow the well to stabilize and re-dyno to evaluate the conditions, equipment loading and counterbalance requirement.

The downhole pumpcard indicates good pump function with a tubing movement of at least 4.0 inches. A sharp load spike is evident at the beginning of the upstroke. Its reflections are evident throughout the stroke. Stuffing box friction is evident and adds at least 500 lbs to the polished rod loading. Consider inspecting and lubricating the stuffing box and the packing.

Reverse the unit rotation and inspect the gearbox for possible chipped tooth.  
 Monitor production, allow the well to stabilize and re-dyno to evaluate the conditions, equipment loading and counterbalance requirement.

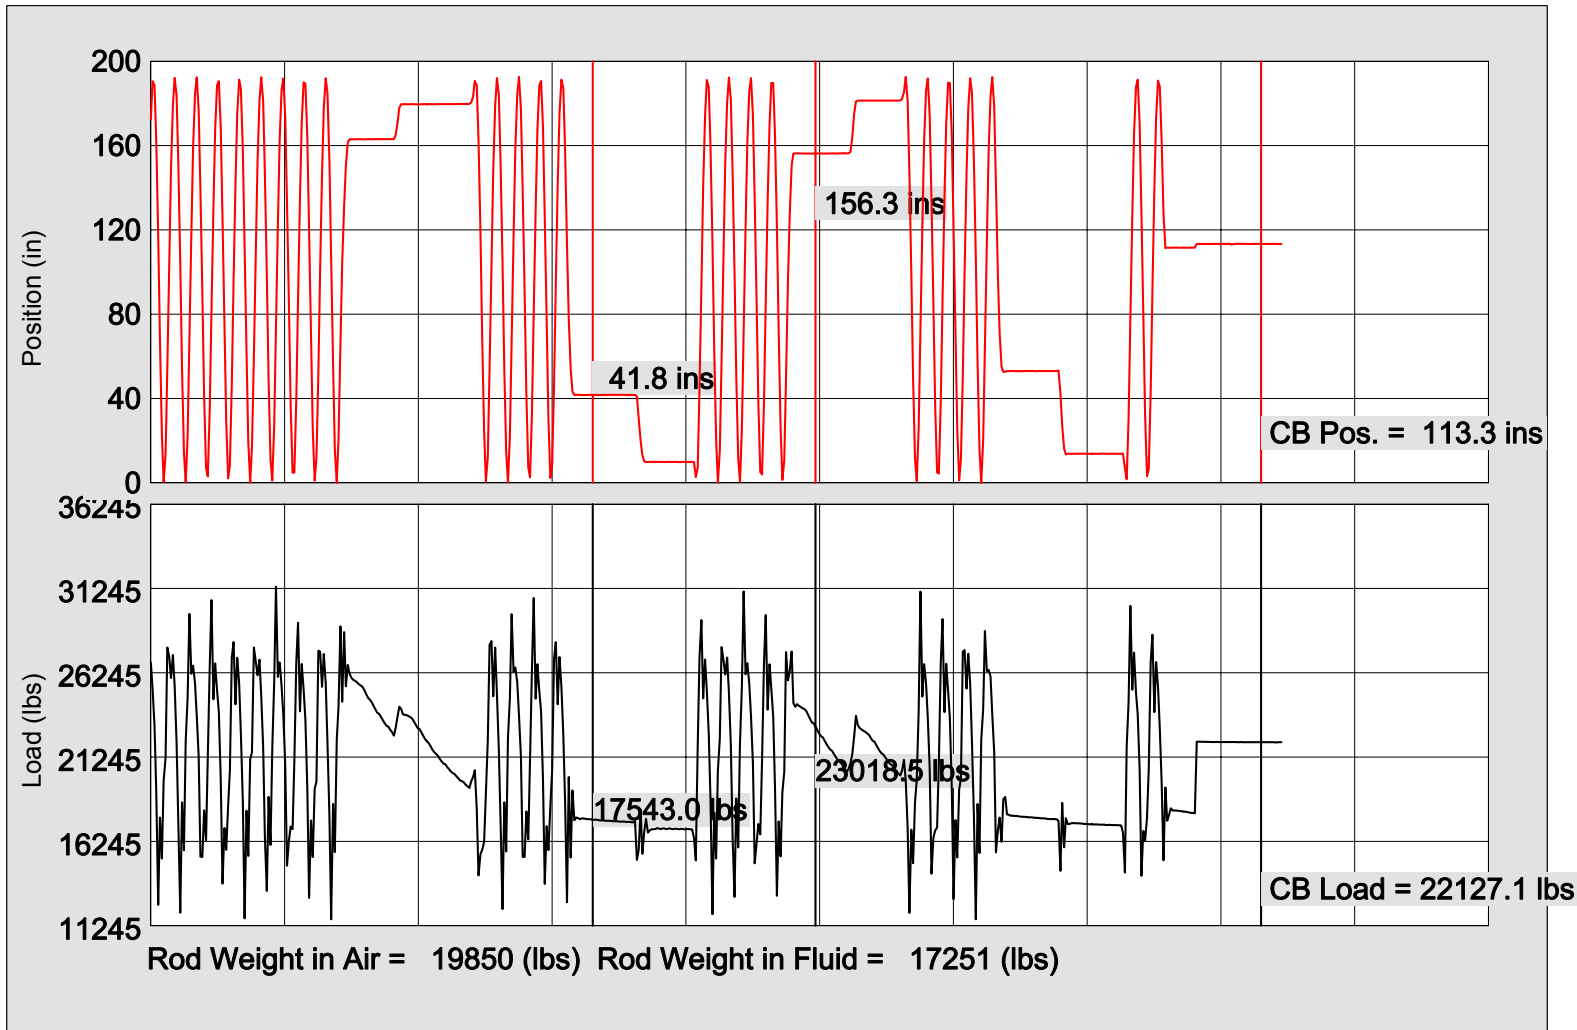
The valve checks indicate that the downhole pump has a slight travel valve leak. This is considered normal for high watercut wells.

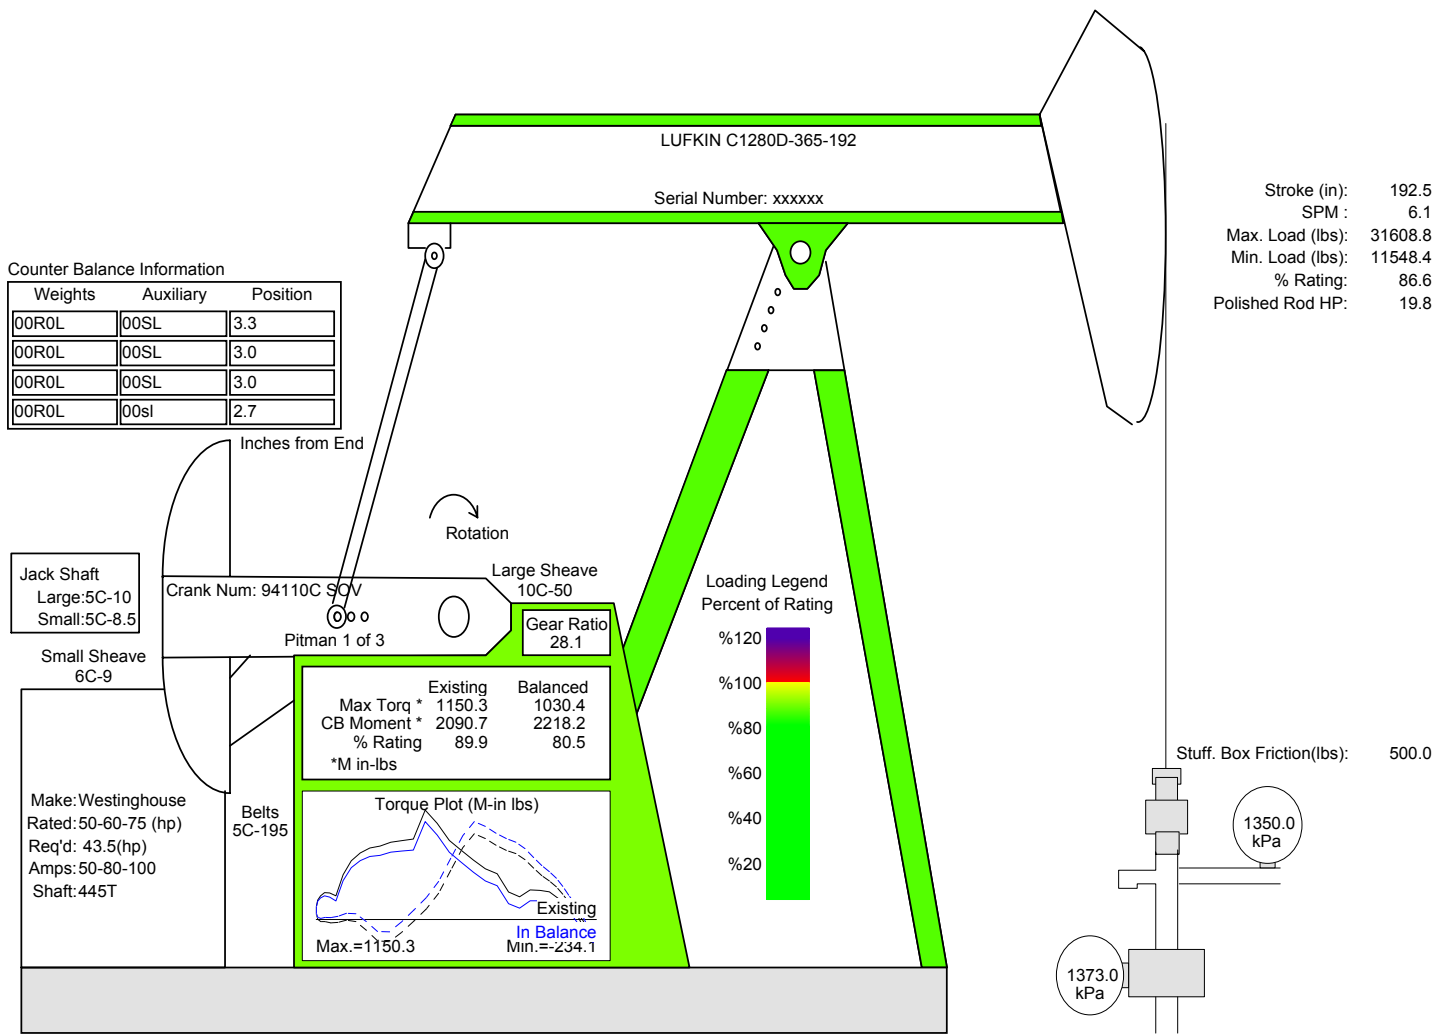
**N.E.R.D.™ Dynamometer is the only system in the world that will collect enough data points to record spikes due to chipped gearbox teeth.  
(See Graph on Page 3)**

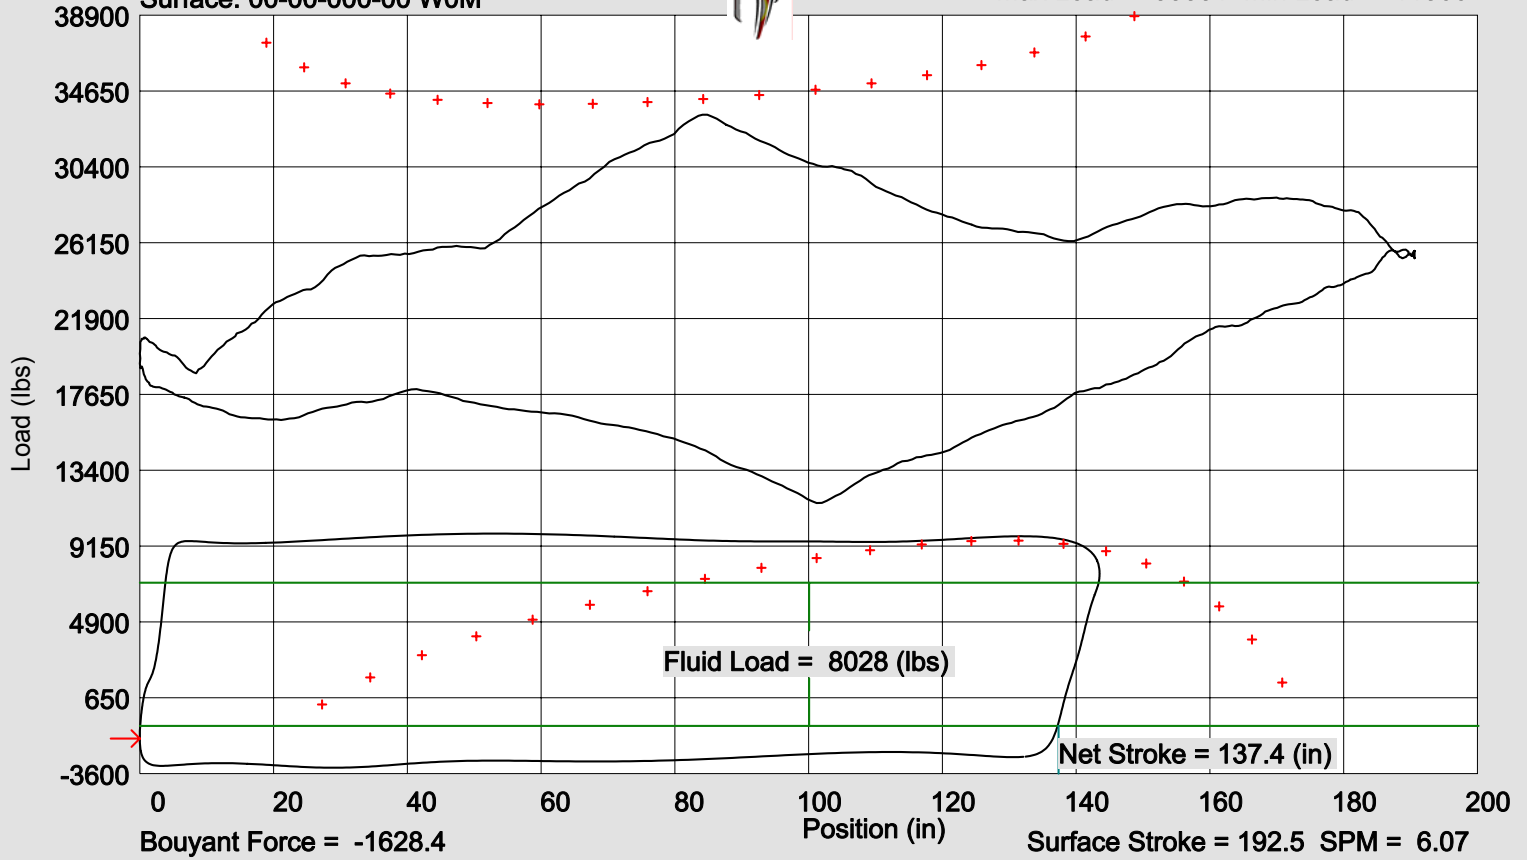
Max Load = 33331 Min Load = 11566

The downhole pumpcard indicates good pump function with tubing movement of 4.0 inches.

The next time the well is serviced, upgrade the existing 19.1 mm grade D rods to a higher strength. To improve production, ensure the tubing anchor is holding properly (tubing movement evident).

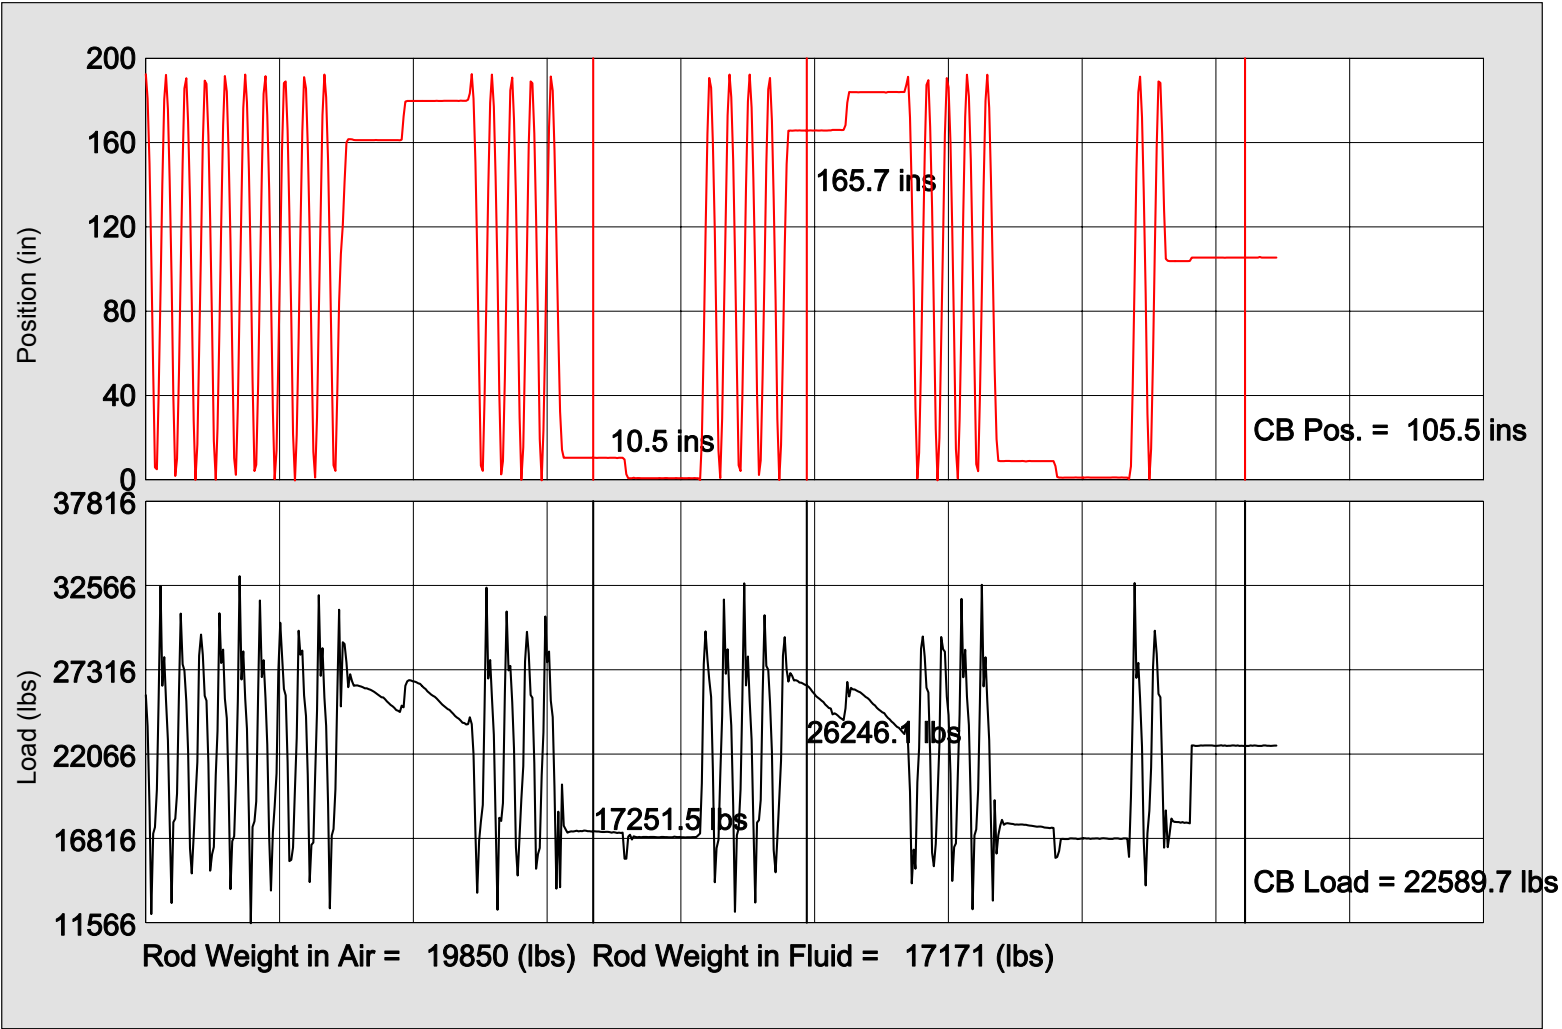
The valve checks indicate that the downhole pump has a slight travel valve leak. This is considered normal for high watercut wells.
