## **Case Study #1**

### **Nelgar's 'Wireless'**

**Foreman's Report/Work Order**

**Dynamometer Analysis**

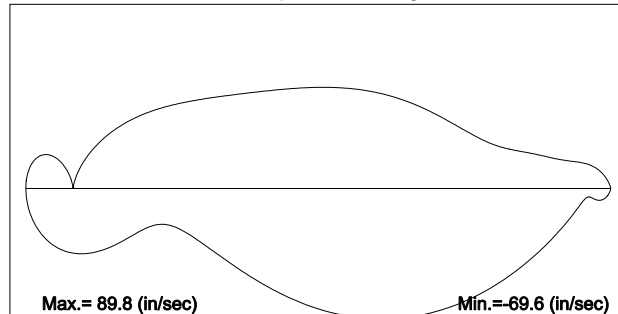
### Pump Velocity

The downhole pumpcard indicates good pump function with a tubing movement of at least 4.0 inches. A sharp load spike is evident at the beginning of the upstroke. Its reflections are evident throughout the stroke. Stuffing box friction is evident and adds at least 500 lbs to the polished rod loading. Consider inspecting and lubricating the stuffing box and the packing.

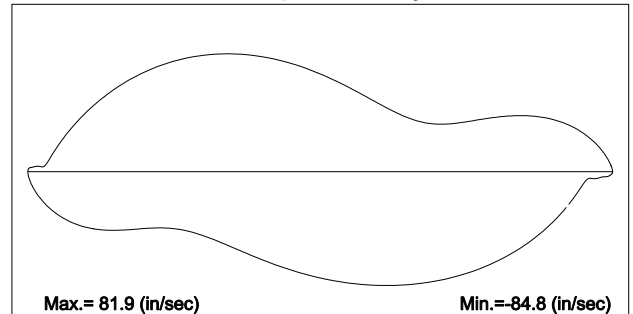
### Pump Velocity

The downhole pumpcard indicates good pump function with tubing movement of 4.0 inches.
